UNITED STATES DISTRICT COURT  
WESTERN DISTRICT OF TEXAS  
AUSTIN DIVISION

JOHN DEUTSH §  
§ CIVIL ACTION NO. 1:15-CV-905  
**Plaintiff** §  
§  
VS. §  
§  
DCW PROPERTIES, LTD. §  
§  
**Defendant** §

**COMPLAINT**

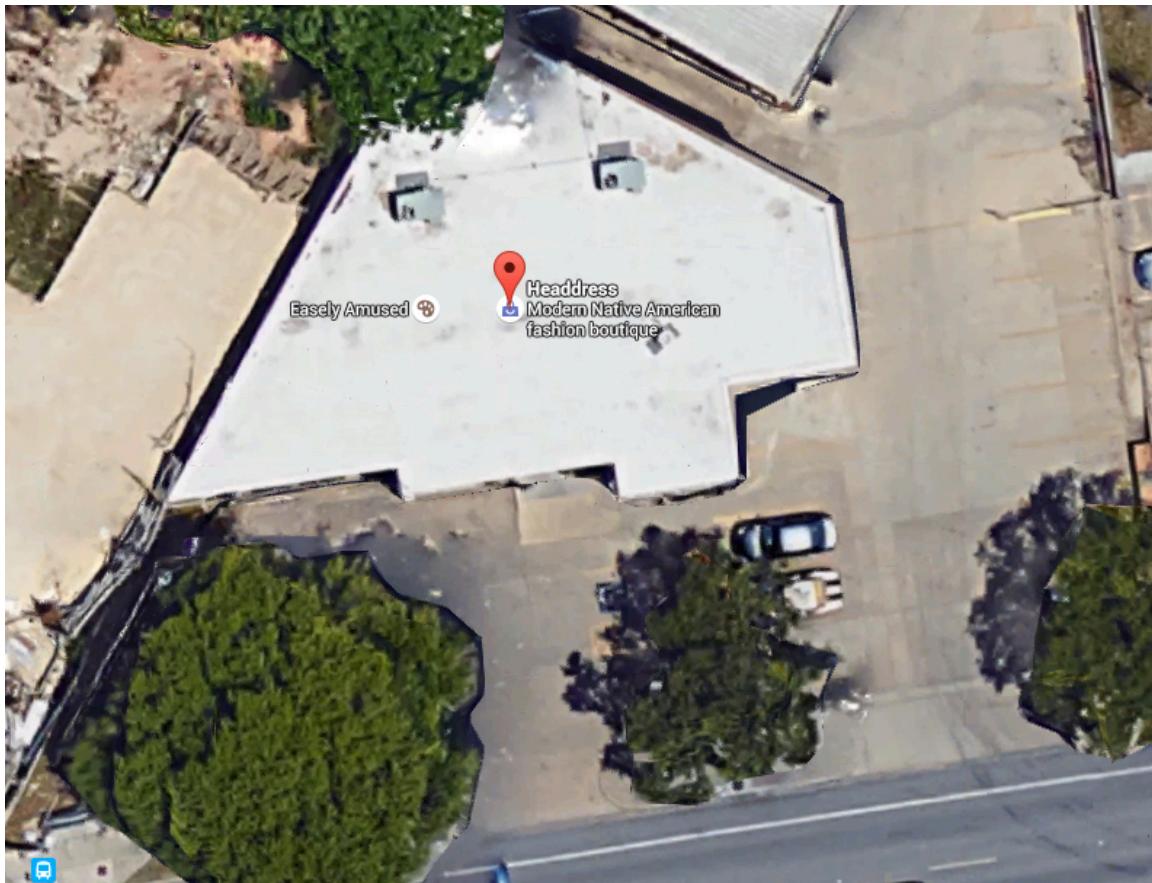
**Fig. 1 - Overhead view of HEADDRESS AUSTIN IN 2015.**

Satellite Images from *Texas General Land Office, Texas Orthoimagery Program, U.S. Geological Survey, 2015*. Note: Zero ADA-Compliant Van Accessible Parking Spaces are Visible (96" Wide with 96" Side Access Aisle). Under the Americans with Disabilities Act, this location must have two ADA-Compliant Parking Spaces, including one ADA-Compliant Van Accessible space (96" Wide with 96" Side Access Aisle).

**Fig. 2 – HEADDRESS AUSTIN.** Note: No ADA-Compliant Van Accessible Spaces (96" Wide with 96" Side Access Aisle). Not ADA Complaint. No Disabled Parking.

**Fig. 3 – View of Storefront Parking.** No ADA-Compliant Parking Spaces. No Signs.

**Fig. 4 – East Side of Parking Lot.** No Disabled Parking.

retail store equally, as required by law, and to compel Defendant to restripe the parking lot in order to add the required numbers of accessible parking spaces. Injunctive relief is also necessary to compel Defendant to modify the building by installing less than  $\frac{1}{2}$ " thresholds at the entrance to be in compliance with federal and state laws.

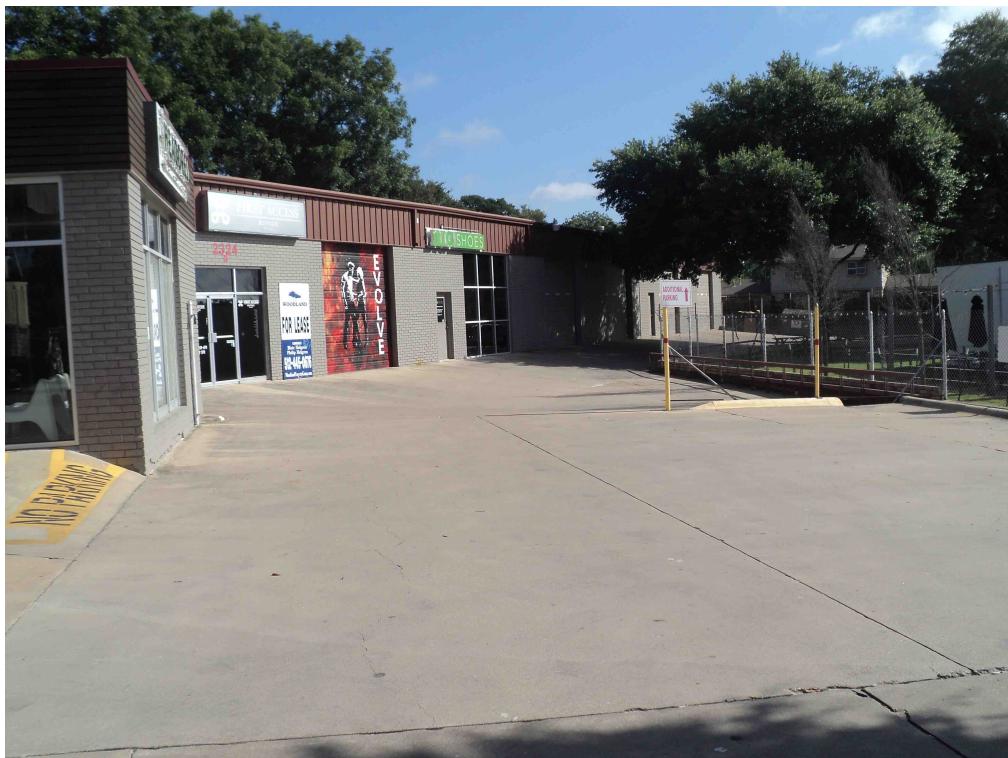
**Fig. 5 – East Side of Building.** No Disabled Parking.

**Fig. 6 – Additional View of Entrance.** No Disabled Parking.

**Fig. 7 – East Side of Parking Lot.** No additional Disabled Parking.

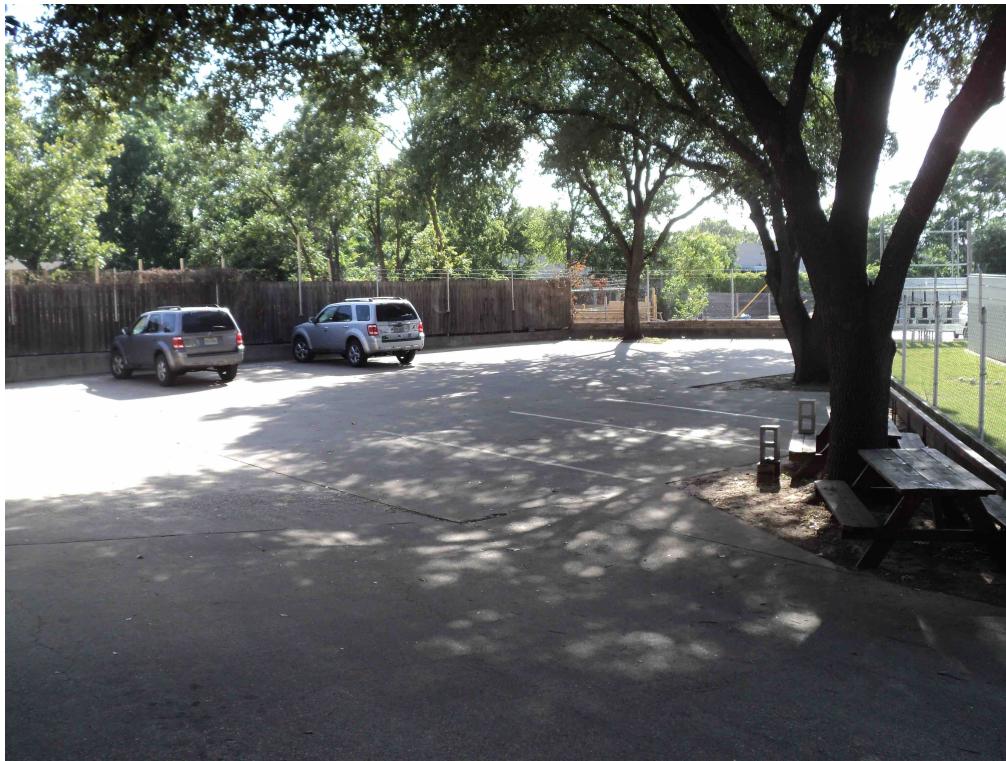
**Fig. 8 – Northeast Corner of Parking Lot.** No additional Disabled Parking.

**Fig. 9 – Disabled Parking Space on Far West Parking Lot.** Not ADA-Compliant. Access Aisle is Too Small. Under the ADA, this business must have 1 Van Accessible Space (96" Wide with 96" Side Access Aisle).

**Fig. 10 – Barriers to Entry.** Person in a Wheelchair from Disabled Parking Spot Cannot Enter Store. This Path is Blocked by Parking for Other Cars.
